## Preliminary Arborist Report

**Stanford Research Institute  
Menlo Park, CA**

**August 2025 REV**

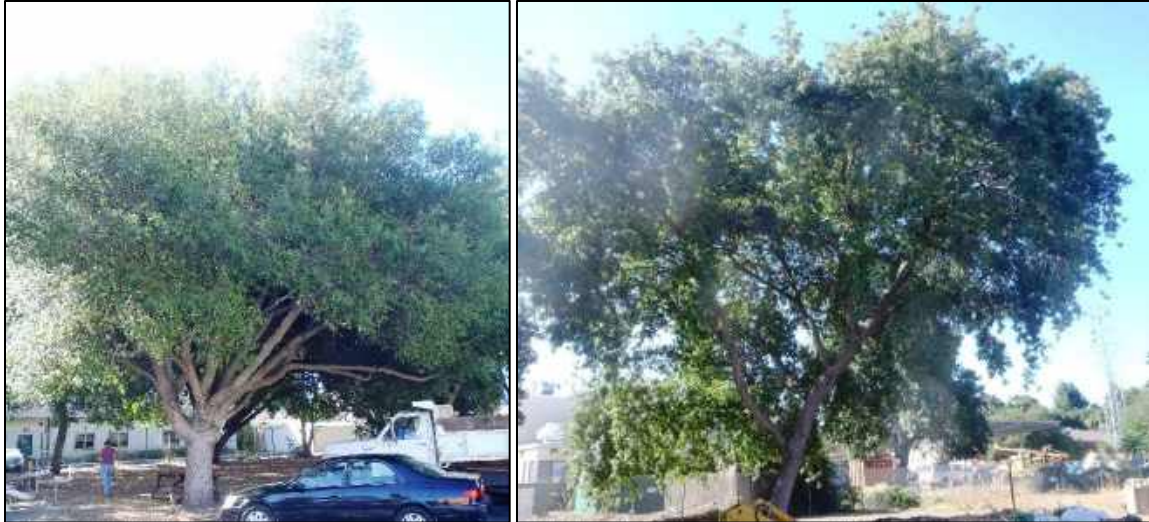
**Photo 1 (L):** Looking south at coast live oak #15. The tree was mature, with a 23" diameter trunk and was in good condition.

**Photo 2 (R):** Looking south at valley oak #26. This tree was in excellent condition, with a slight lean to the northeast.

- Valley oak #26 (Photo 2) was a semi-mature tree growing at the east end of the Area 1 oak grove. It measured 19" in trunk diameter and was in excellent condition.

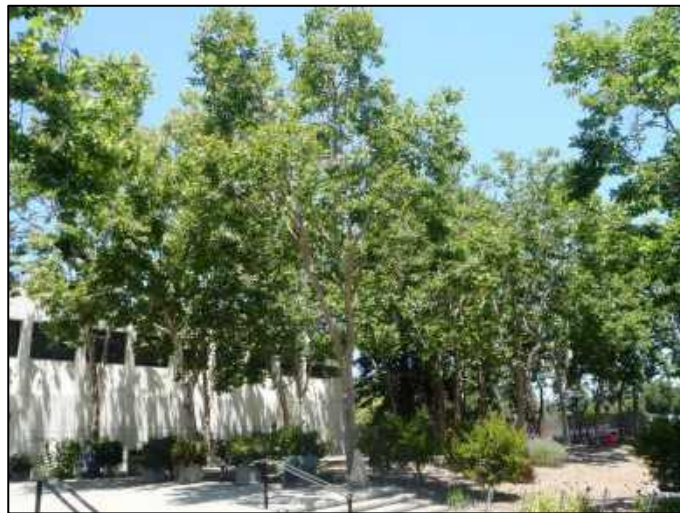
**Photo 3:** Looking north at London planes #360 - 368. The trees were generally semi-mature in development and in fair and good condition.

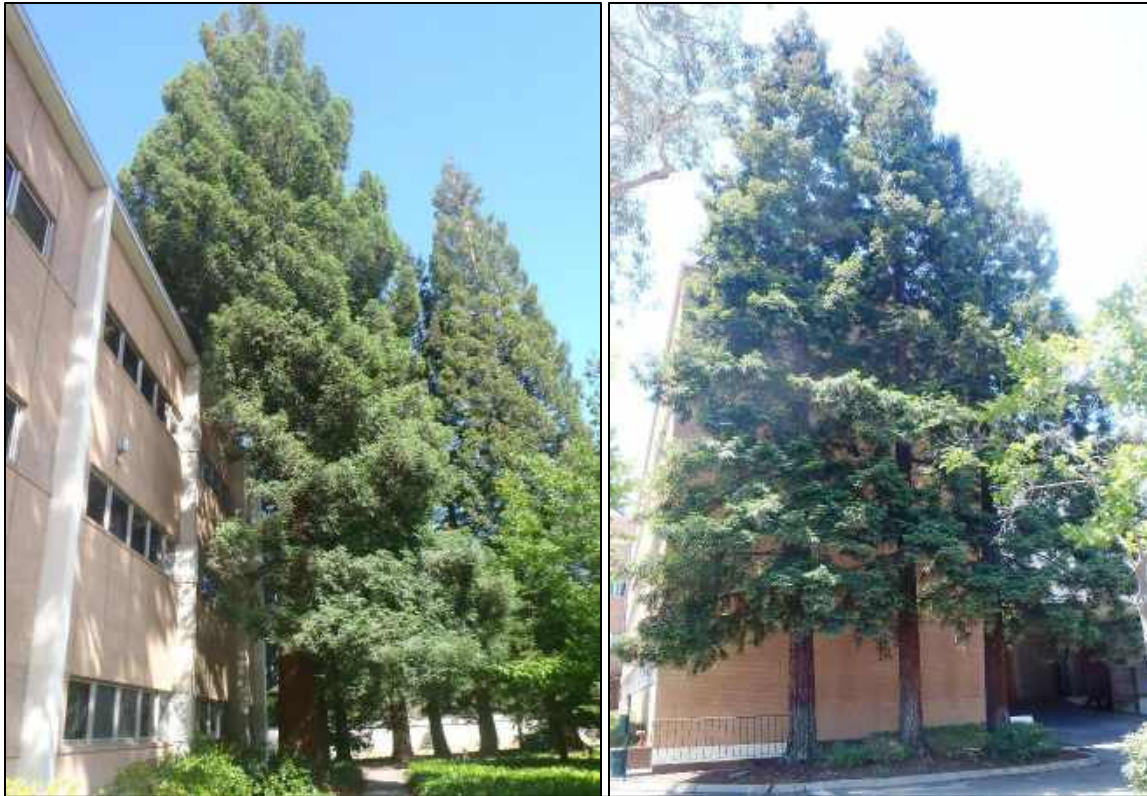
**Photo 4** (above left). Looking west at coast redwood #453, a 50" diameter tree growing at the intersection of Areas 2 and 4a and immediately adjacent to building A. The tree was mature and in good condition, representative of many redwoods in Areas 2 and 4a.

**Photo 5** (above right): Looking west at coast redwoods #340 - 342 (L to R) which were semi-mature in development, 21 or 22" in diameter, and growing in a medium-sized planter on the east side of Building A.

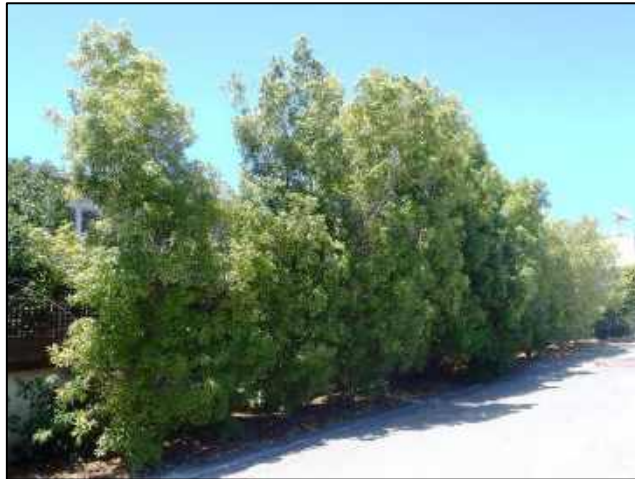
**Photo 6.** Looking west at a row of Victorian box #552 - 561 (L to R) located along the perimeter of the parking lot. They provided critical screening between the SRI campus and the adjacent residences to the west.

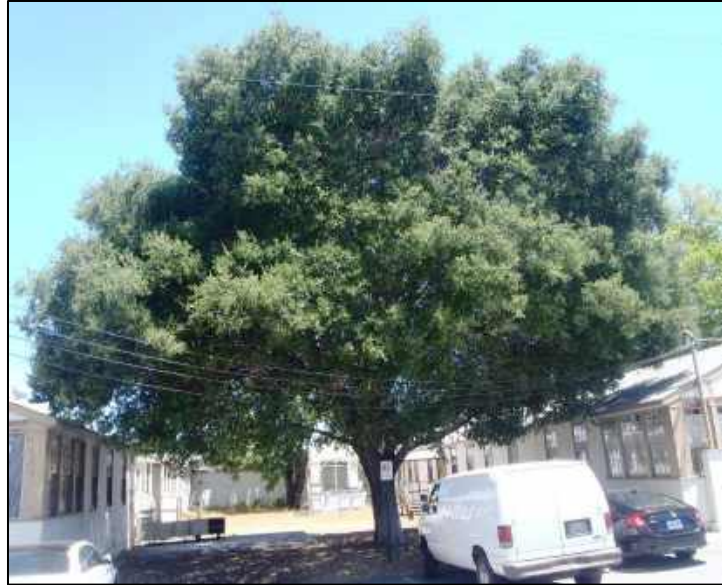
- Coast live oak #151 (Photo 7) was a mature tree growing between Bldgs. 2 and 4 in Area 1. It measured 42" in trunk diameter and was in excellent condition, despite having been pruned on the west side for the overhead utilities.

**Photo 7:** Looking northeast at coast live oak #151. The tree was mature at 42" in trunk diameter and in excellent condition. The canopy had been pruned on the west side for utilities.

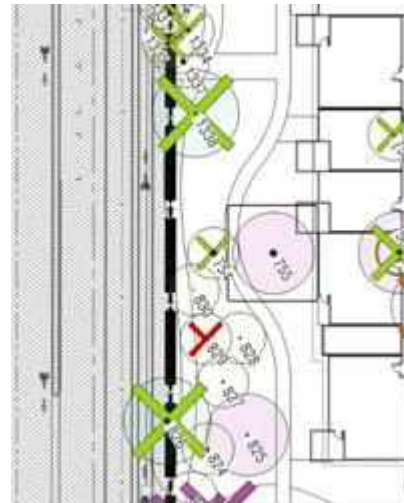
**Figure 1.** Tree #755 in purple is shown for preservation but the design will need to be modified to preserve the tree.

As an example, coast live oak #755 is located near Laurel Street in a parking lot median, a modification would be needed to preserve the tree (Figure 1). Preservation is likely. I recommend modifying the design to incorporate preservation of these trees wherever possible.
